Technical Service Bulletin

| Technical Service Bulletin: TSB200249 | Released Date: 21-Dec-2020 |

Fault Code 2349 Caused by Poor OEM Power Supply or Return Connections

- X15 CM2450 X124B
- X15 CM2450 X134B

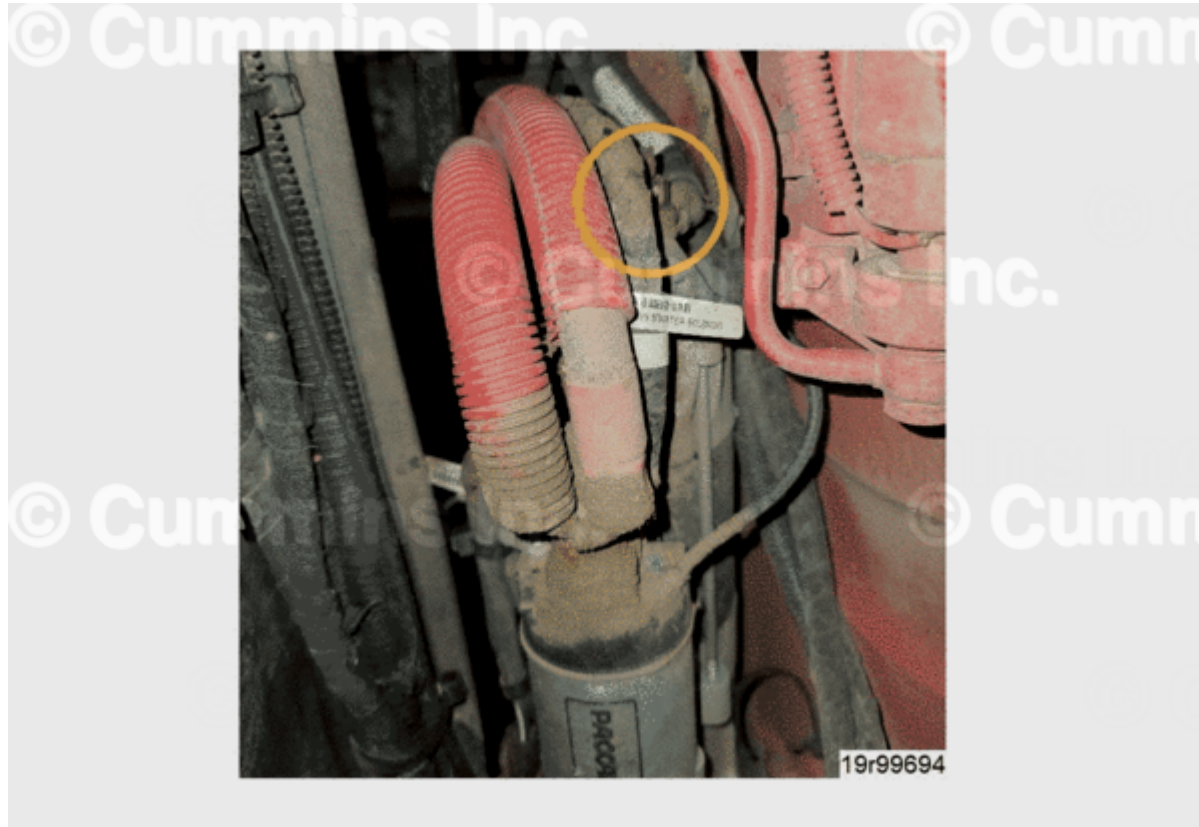
- Loose power supply return (ground) connection at the starter. See equipment manufacturer service information.
 - Poor electrical connections for unswitched power supply and return circuit at the J2 OEM – ECM Delphi® 96 Way Engine Control Module Connector. See equipment manufacturer service information. See corresponding Service Manual. Reference Procedure 019-087, 019-505 in Section 19.

Figure 1, Location of Loose Power Return (Ground) Connection at Starter that Resulted in Fault Code 2349.

- If any issues are identified with OEM power supply, returns (grounds), or J2 OEM – ECM unswitched power supply connections, repair or replace as necessary. Reference Procedure 013-009 in Section 13; 019-008, 019-087, 19-505 in Section 19; and/or OEM Service Manual.
- Connect the recommended Cummins® electronic service tool or equivalent.
- Disable the fault code.
- Operate the engine within the "Conditions for Clearing the Fault Code" found in the Overview section of the troubleshooting procedure.
- Verify that the fault code is no longer active.
- Check ECM Calibration Revision History.

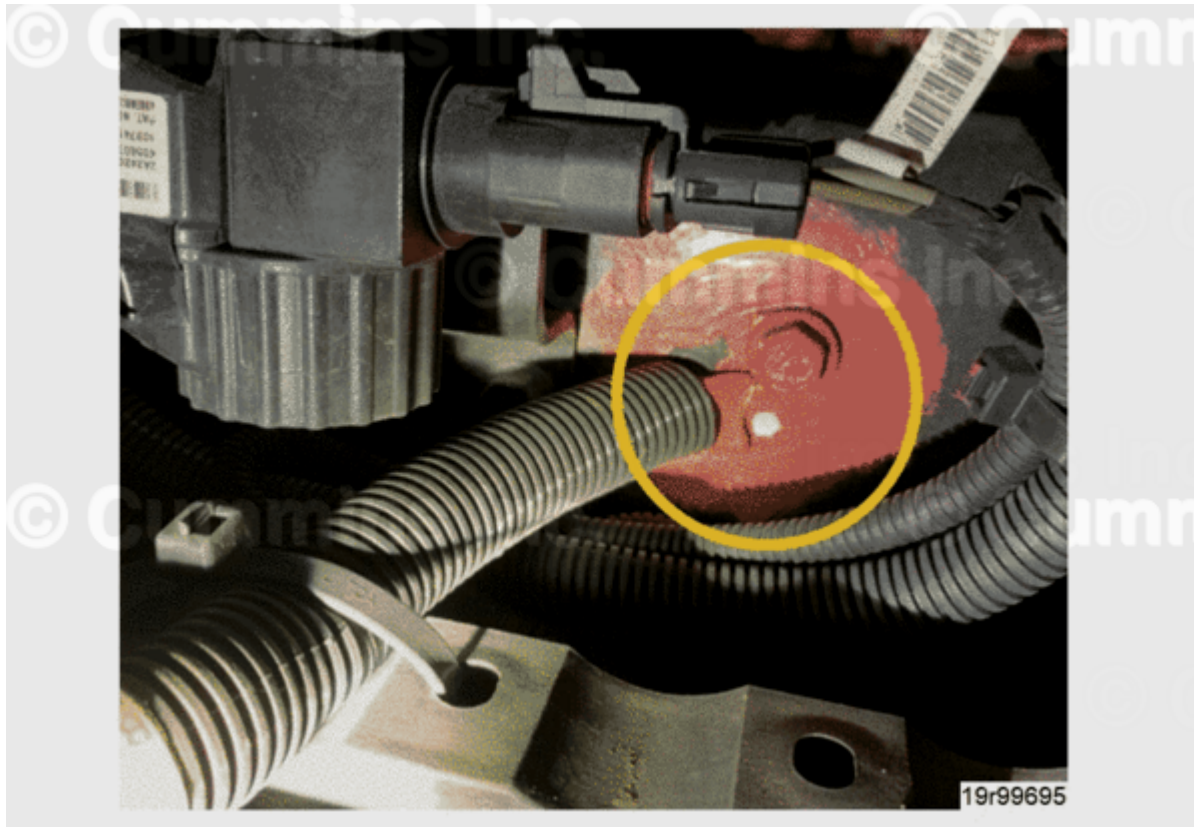
- Broken or loose battery negative to chassis connection. See equipment manufacturer service information. See corresponding Service Manual. Reference Procedure 019-008 in Section 19.

Figure 2, Example of Broken Power Return (Ground) Connection from Battery to Chassis that Resulted in Fault Code 2349.

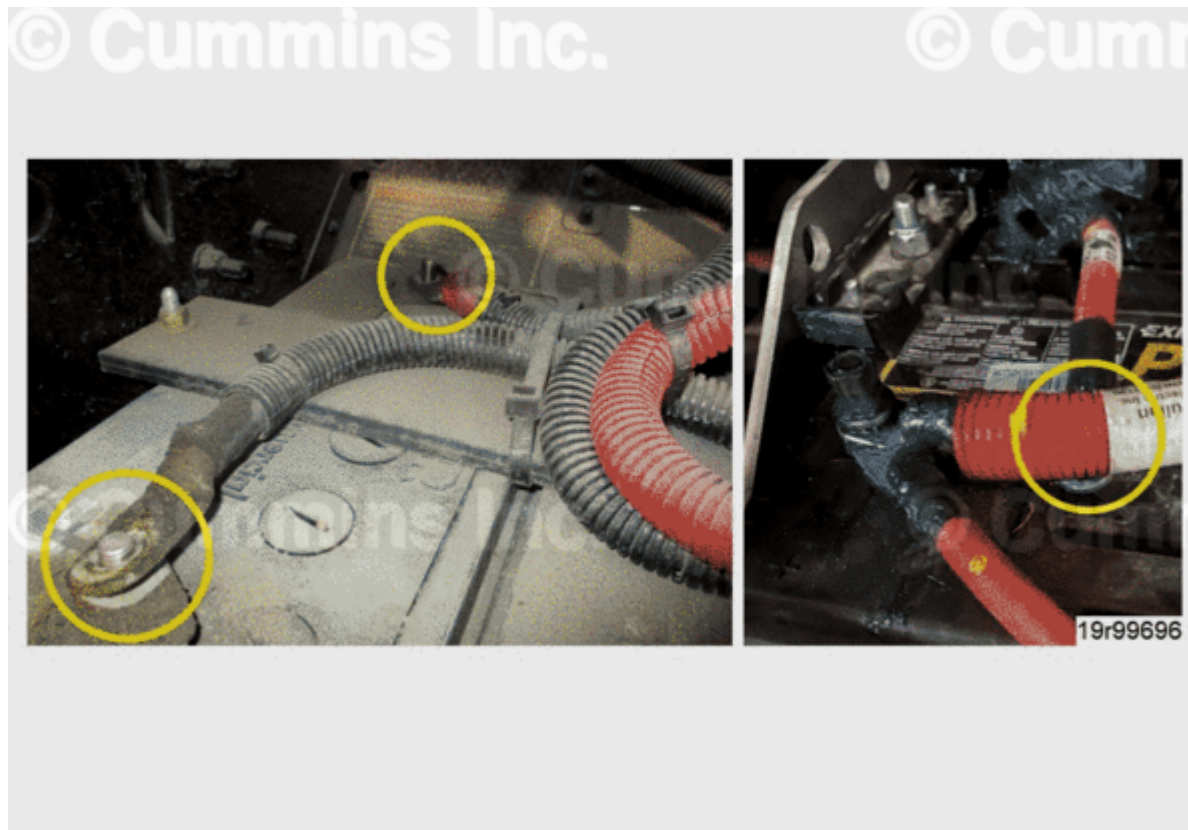
- Disconnected or loose battery cable connections. See equipment manufacturer service information. See corresponding Service Manual. Reference Procedure 013-009 in Section 13.

Figure 3, Two Examples of Loose or Disconnected Battery Cables that Both Resulted in Fault Code 2349.
